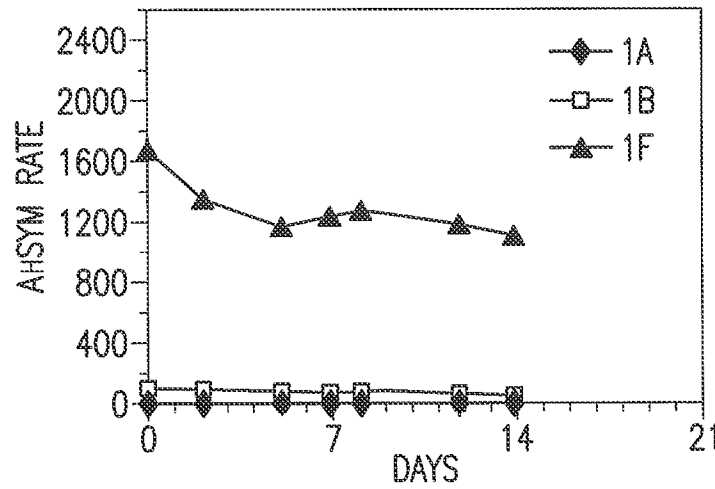
FIG.1A

MMSTABILITY6 IN DiI1 @37°C.

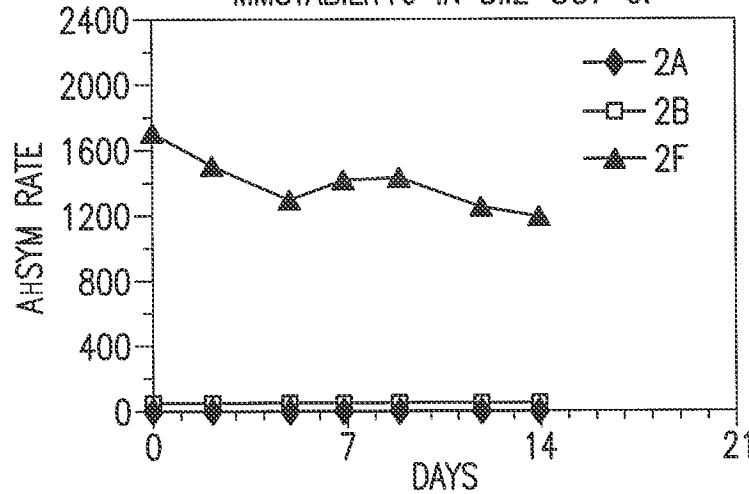
FIG.1B

MMSTABILITY6 IN DiI2 @37°C.

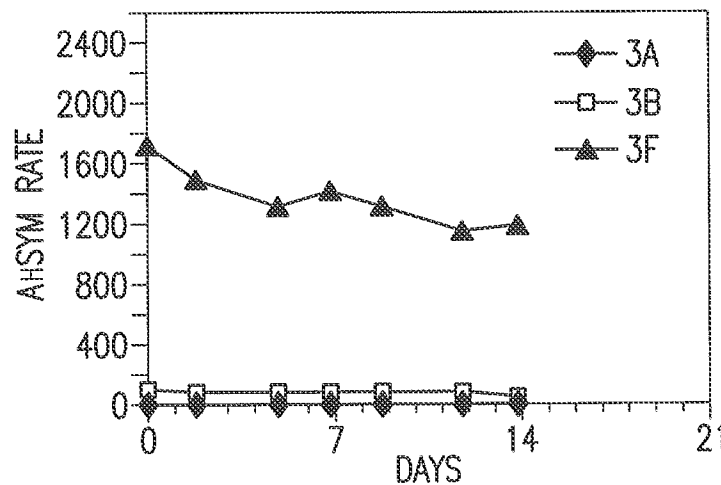
FIG.1C

MMSTABILITY6 IN DiI3 @37°C.

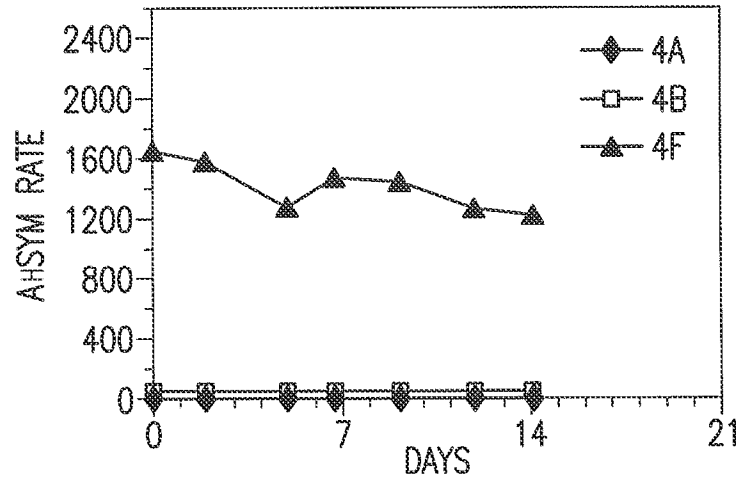
FIG.1D

MMSTABILITY6 IN DiI4 @37°C.

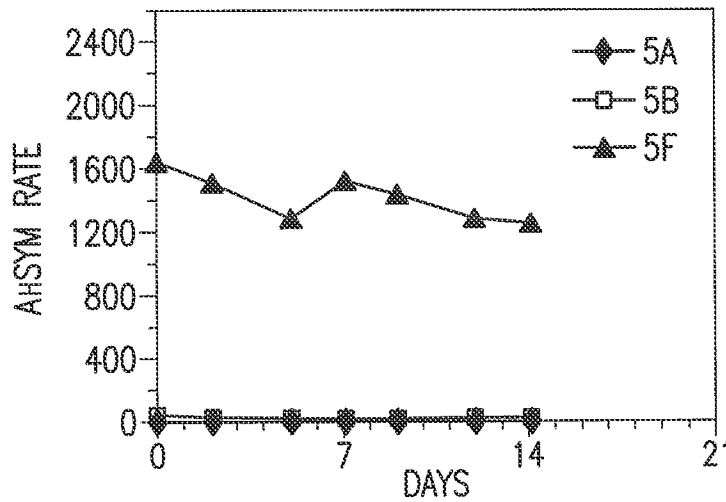
FIG.1E

MMSTABILITY6 IN DiI5 @37°C.

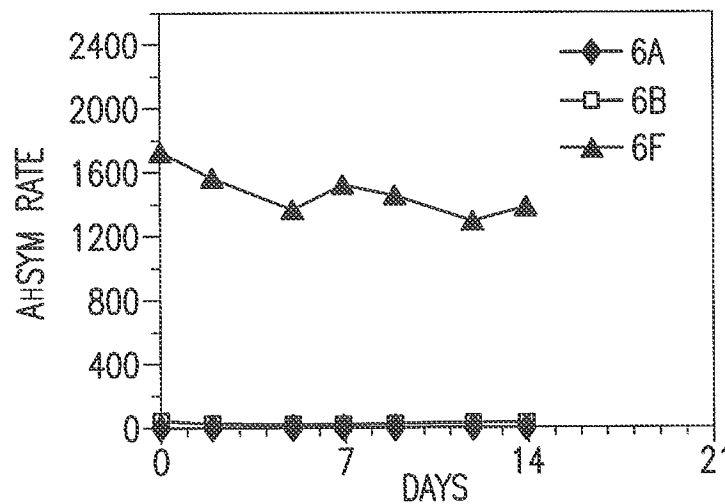
FIG.1F

MMSTABILITY6 IN DiI6 @37°C.

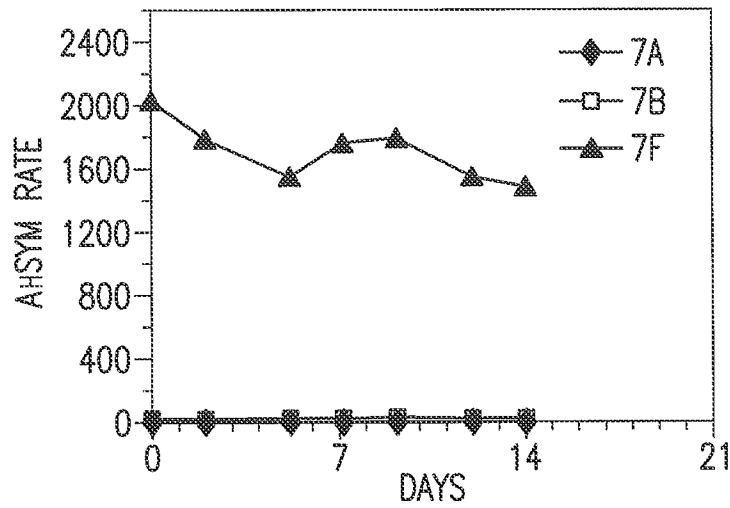
FIG.1G

MMSTABILITY6 IN DiI7 @37°C.

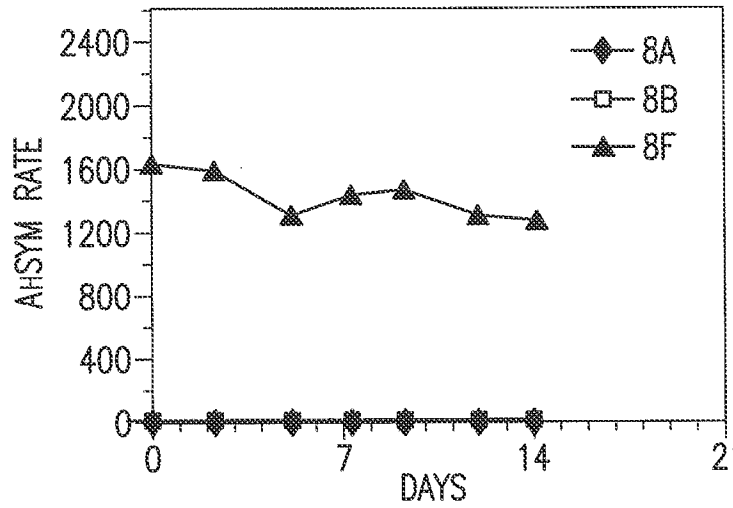
FIG.1H

MMSTABILITY6 IN DiI8 @37°C.

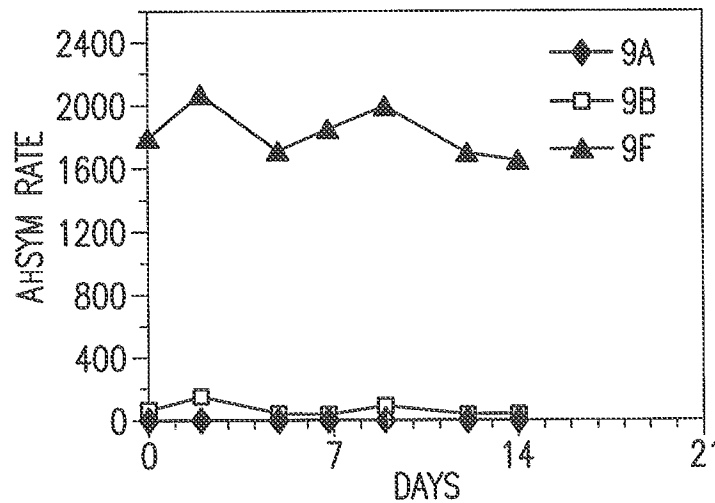
FIG.1I

MMSTABILITY6 IN DiI9 @37°C.

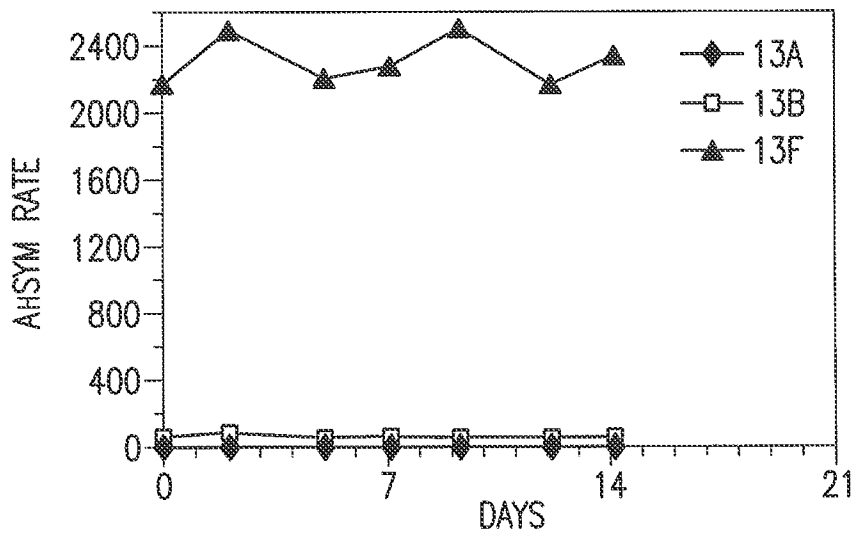
FIG.1M

MMSTABILITY6 IN DII13 @37°C.

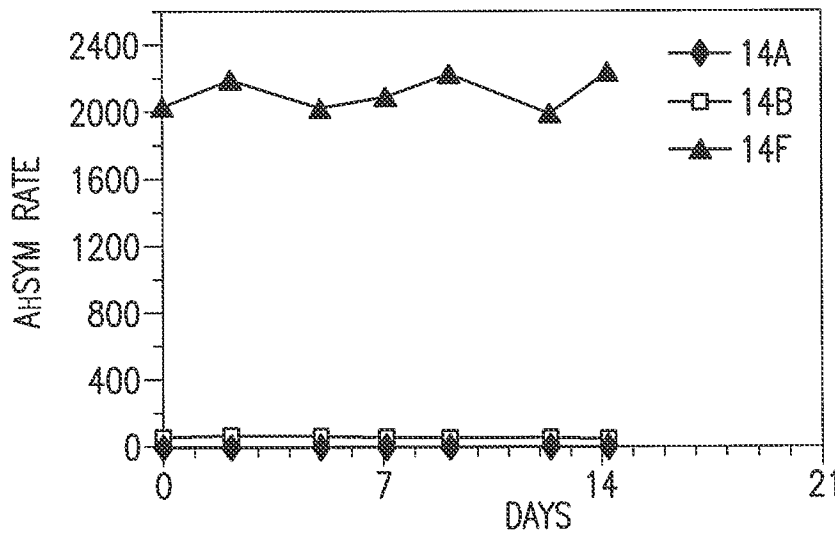
FIG.1N

MMSTABILITY6 IN DII14 @37°C.

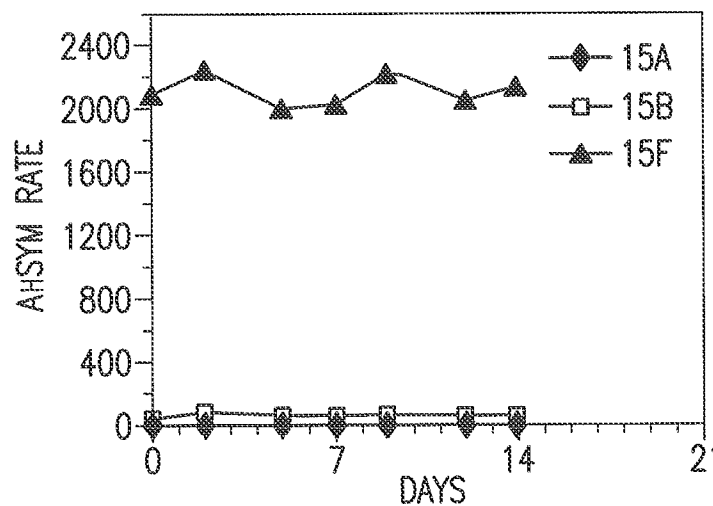
FIG.1O

MMSTABILITY6 IN DII15 @37°C.

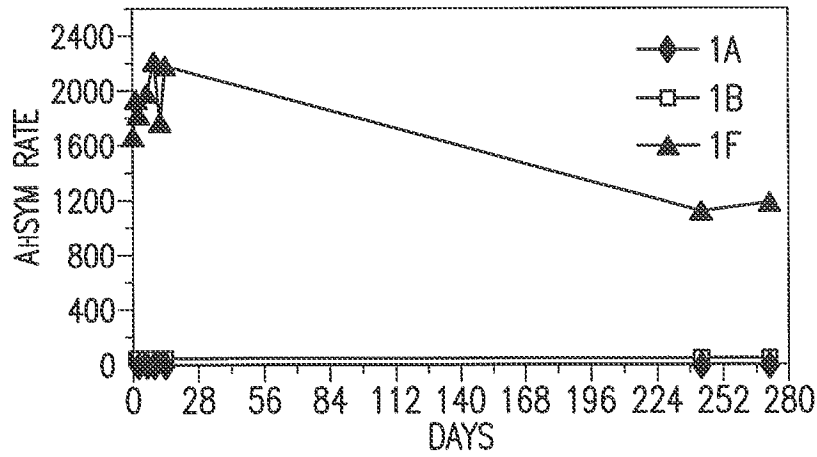
FIG.2A

MMSTABILITY6 IN DiI1 @2-8°C.

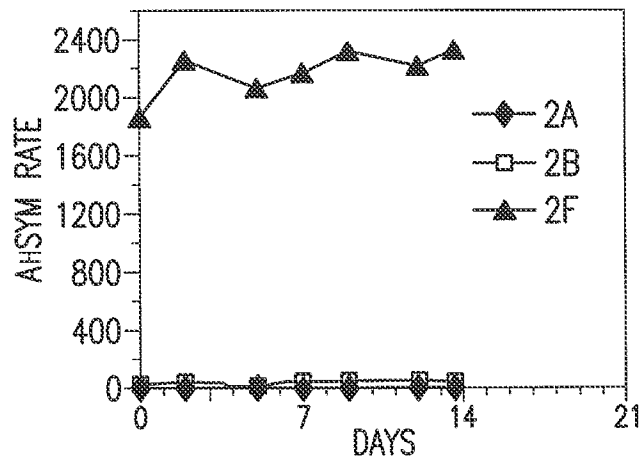
FIG.2B

MMSTABILITY6 IN DiI2 @2-8°C.

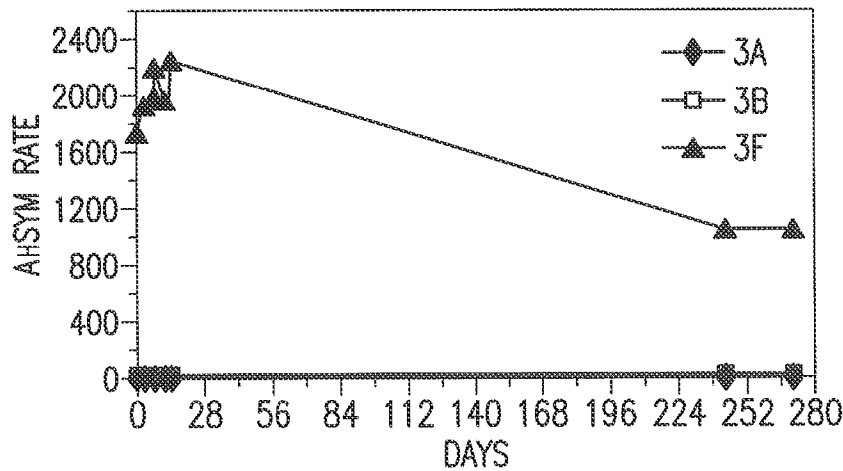
FIG.2C

MMSTABILITY6 IN DiI3 @2-8°C.

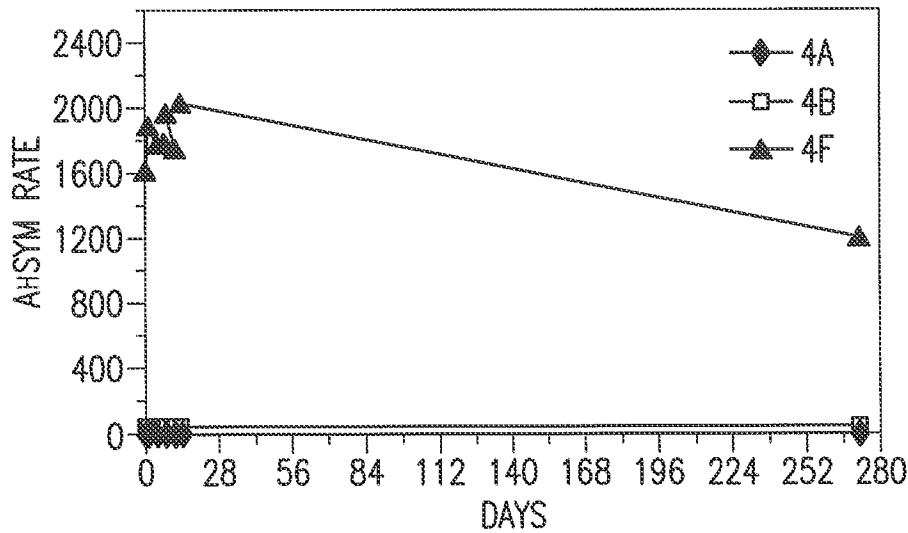
FIG.2D

MMSTABILITY6 IN DiI4 @2-8°C.

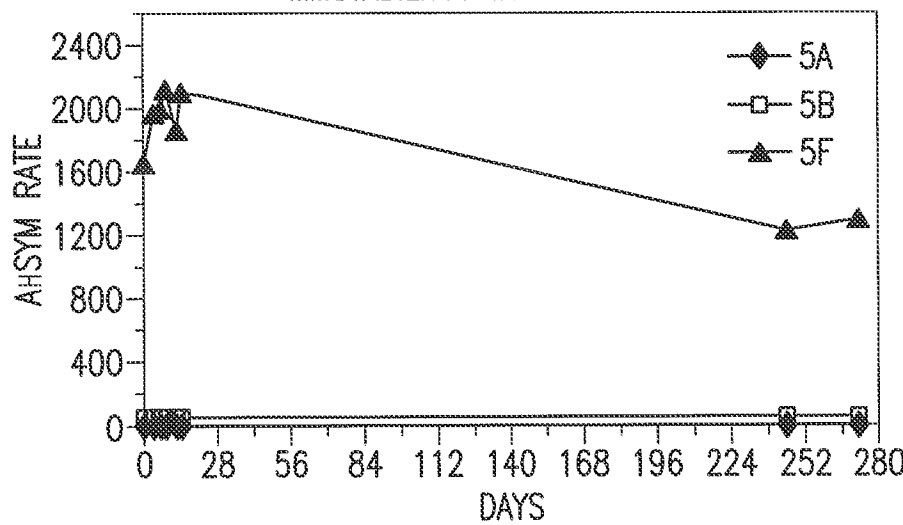
FIG.2E

MMSTABILITY6 IN DiI5 @2-8°C.

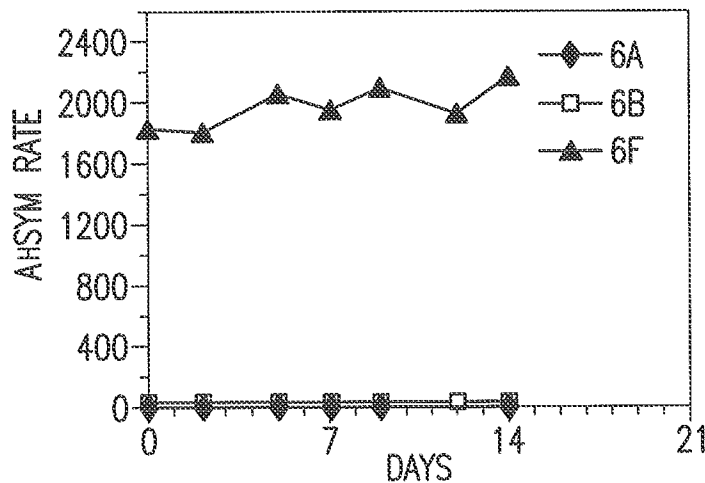
FIG.2F

MMSTABILITY6 IN DiI6 @2-8°C.

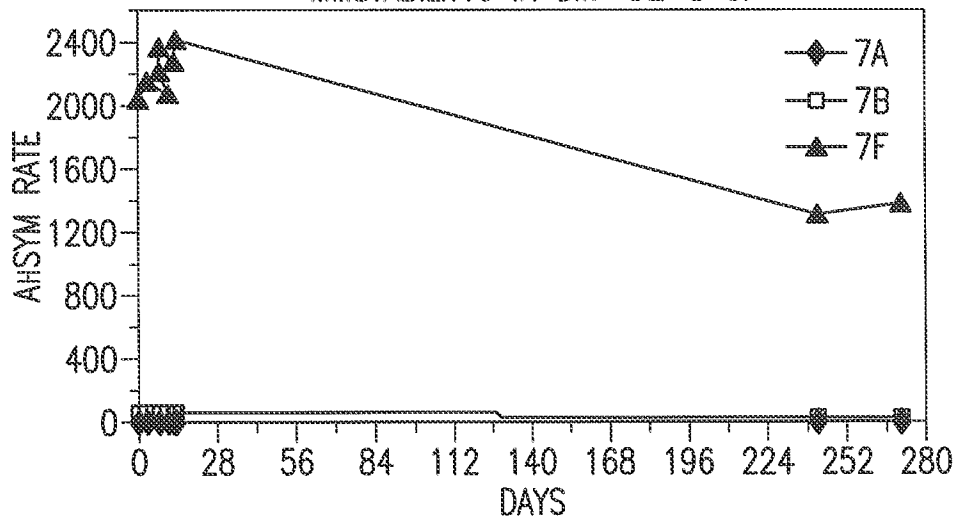
FIG.2G

MMSTABILITY6 IN DiI7 @2-8°C.

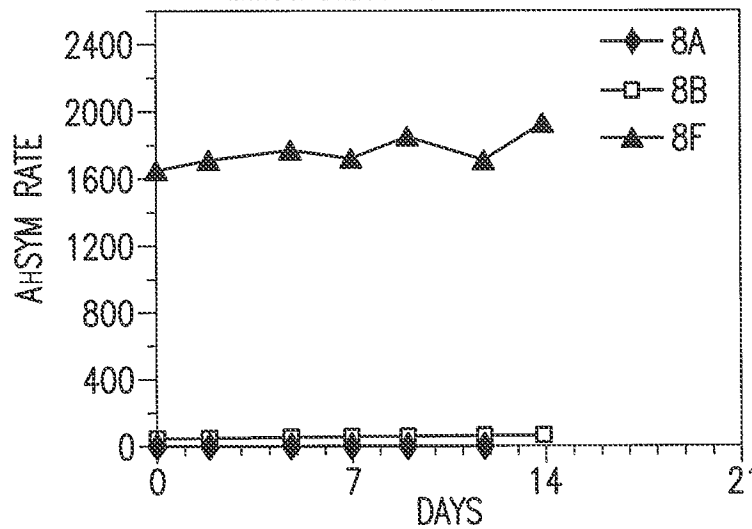
FIG.2H

MMSTABILITY6 IN DiI8 @2-8°C.

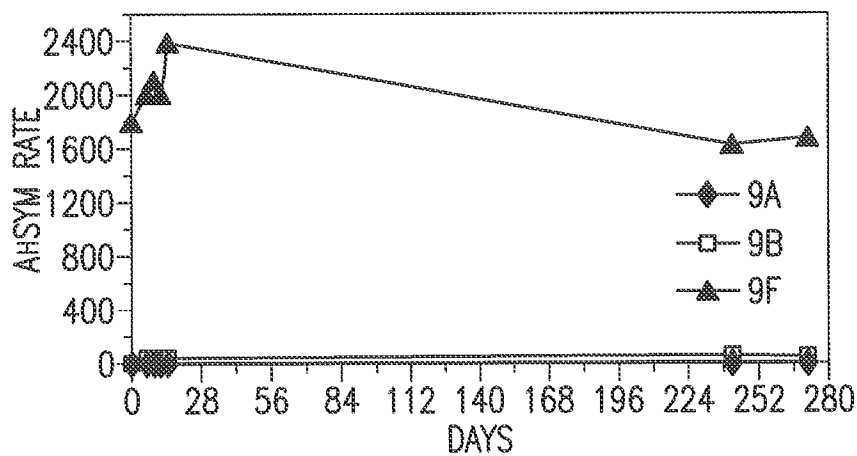
FIG.2I

MMSTABILITY6 IN DiI9 @2-8°C.

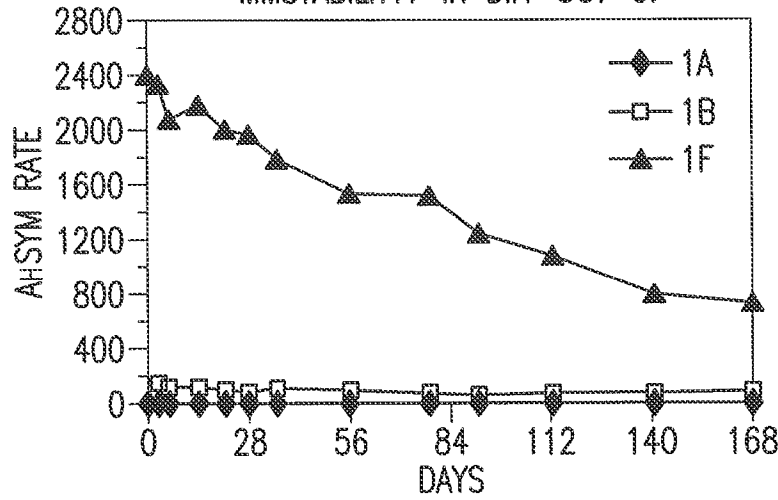
FIG.3A

MMSTABILITY7 IN DiI1 @37°C.

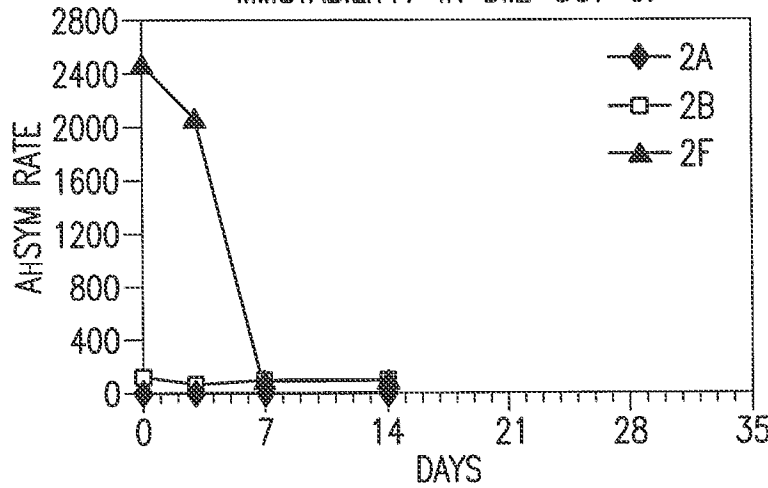
FIG.3B

MMSTABILITY7 IN DiI2 @37°C.

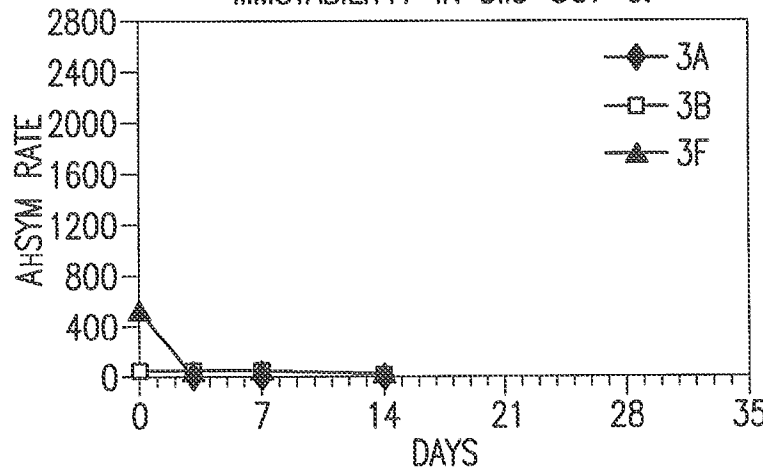
FIG.3C

MMSTABILITY7 IN DiI3 @37°C.

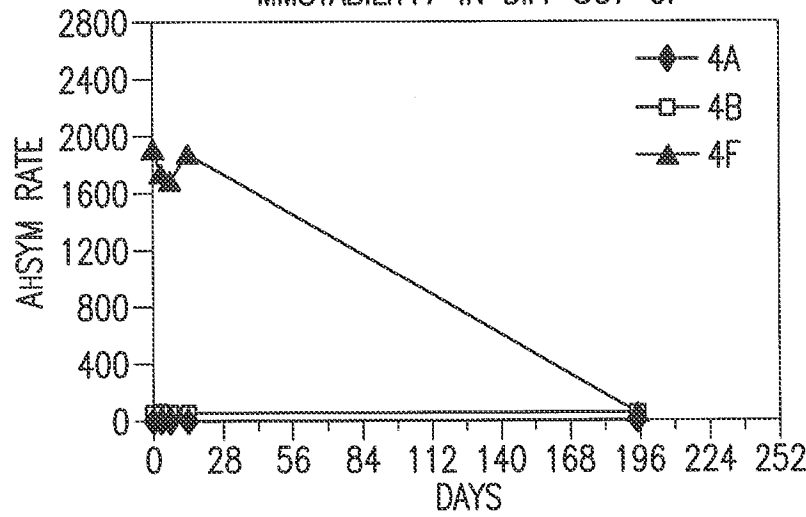
FIG.3D

MMSTABILITY7 IN DiI4 @37°C.

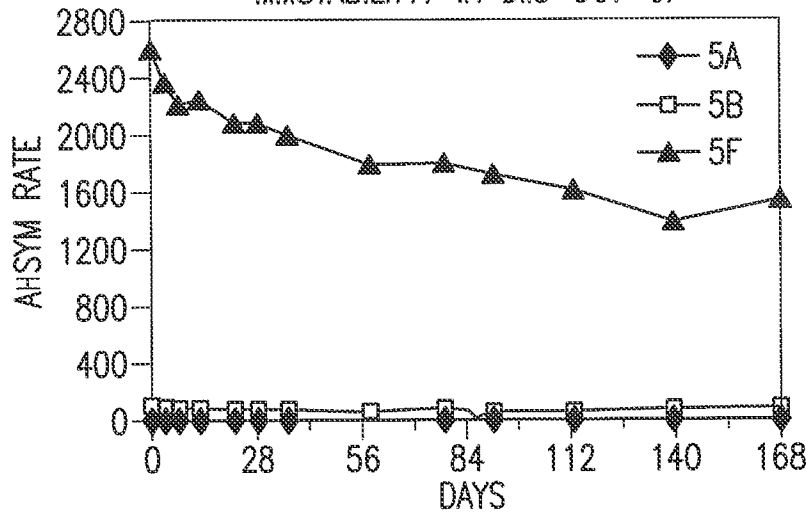
FIG.3E

MMSTABILITY7 IN DiI5 @37°C.

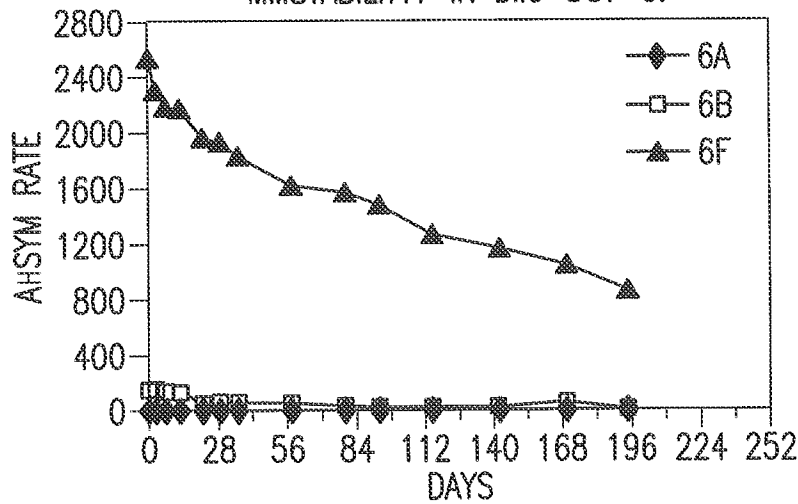
FIG.3F

MMSTABILITY7 IN DiI6 @37°C.

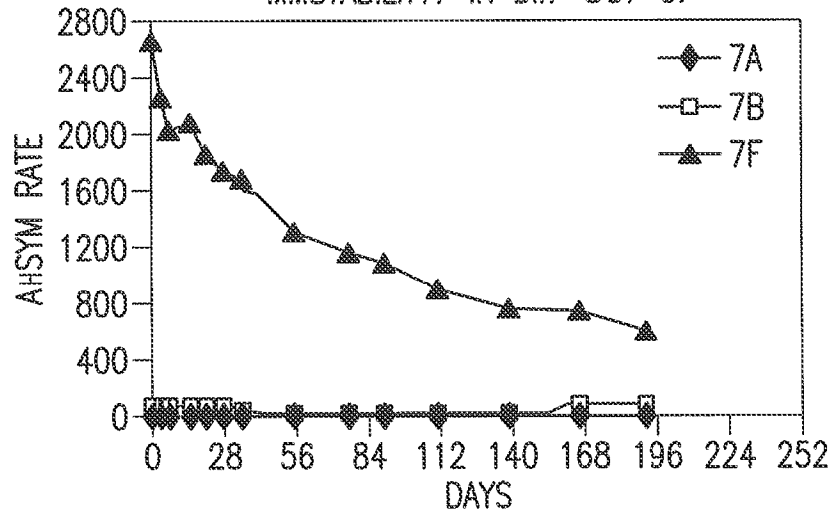
FIG.3G

MMSTABILITY7 IN DII7 @37°C.

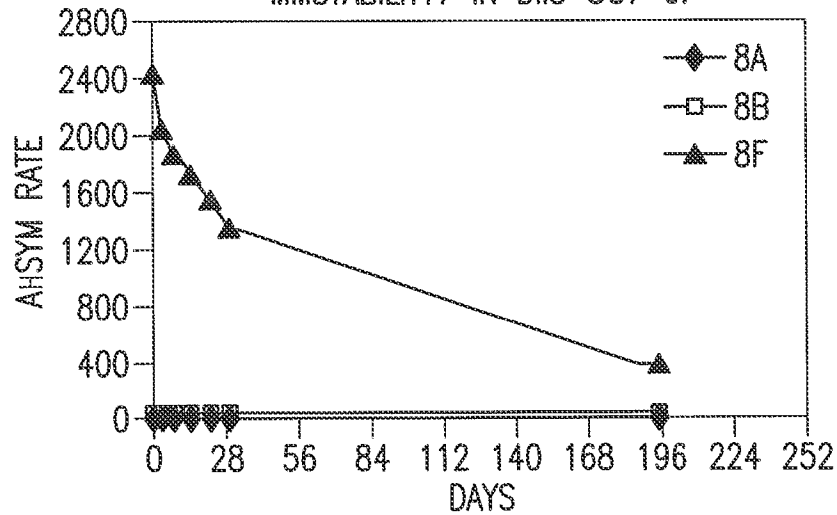
FIG.3H

MMSTABILITY7 IN DII8 @37°C.

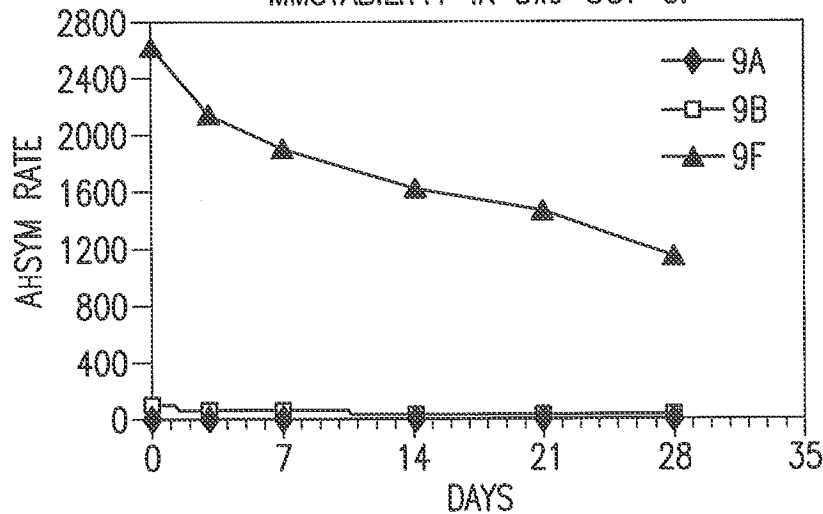
FIG.3I

MMSTABILITY7 IN DII9 @37°C.

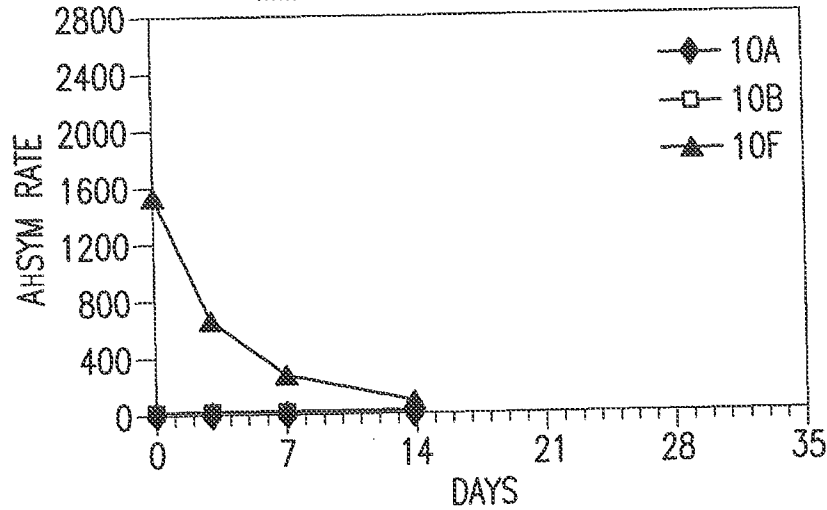
FIG.3J

MMSTABILITY7 IN Di110 @37°C.

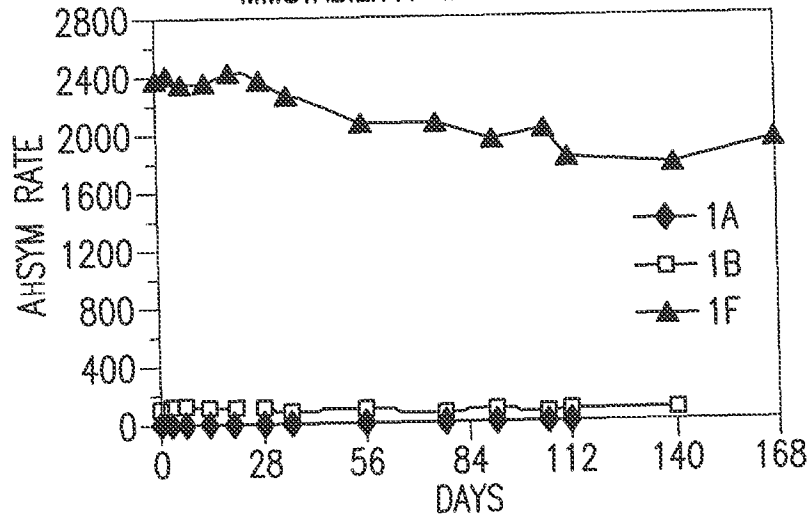
FIG.3K

MMSTABILITY7 IN Di11 @2-8°C.

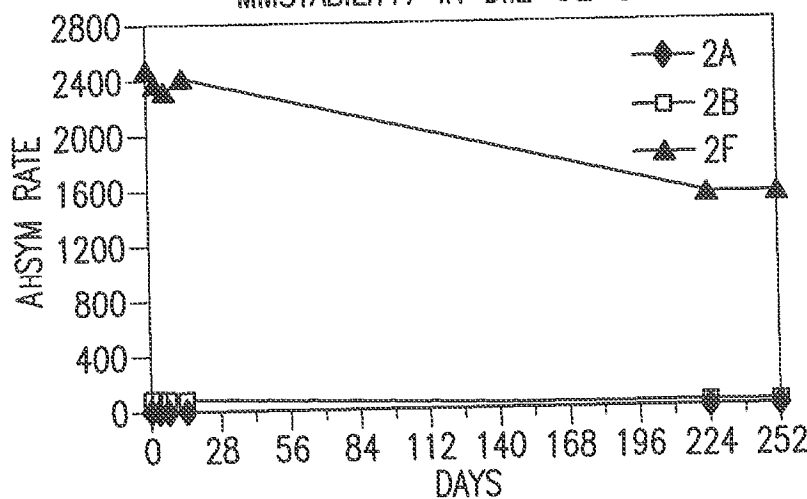
FIG.3L

MMSTABILITY7 IN Di12 @2-8°C.
